Manhole Inspection Summary

Manhole # S41C2_010MH

Location Address: **920 Stoll St.**

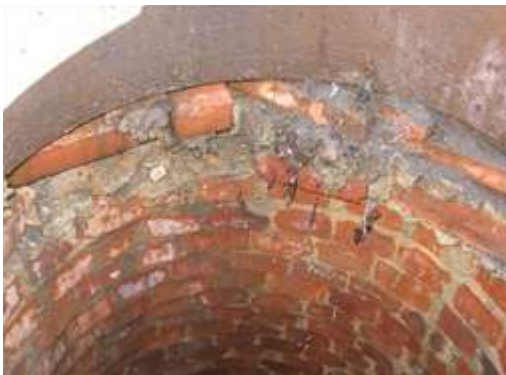
Defect 1

Condition: ☐ Sound ☐ Cracked ☐ Root Intrusion ☒ **Loose Brick** ☐ Deteriorated

Infiltration: ☐ None ☐ Joint ☐ Cracks ☒ **Mortar** ☐ Roots ☒ **Wall**

Infiltration: ☐ None ☐ Joint ☐ Cracks ☒ **Mortar** ☐ Roots ☐ Wall

Loose bricks

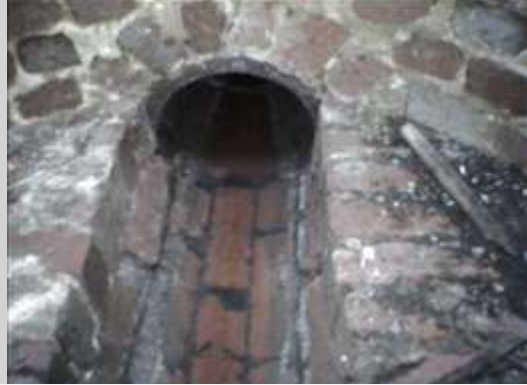
12 O'Clock Outflow

8 in. Circular Gravity Sewer
Pipe Out @ 12 O'Clock

Pipe Height: **9.6** (in.) Rod and Bar (Angled)
Pipe Material: **Clay** ☐ Pipe Lined
Invert Depth: **7.68** (ft.) Flow Characteristics: **Slow**
Deposits: ☒ None ☐ Mud ☐ Sludge ☐ Debris ☐ Grease
Silt Depth: (in.) Deposits Extent:
Infiltration: **None** Pipe Seal Cond: **Sound**

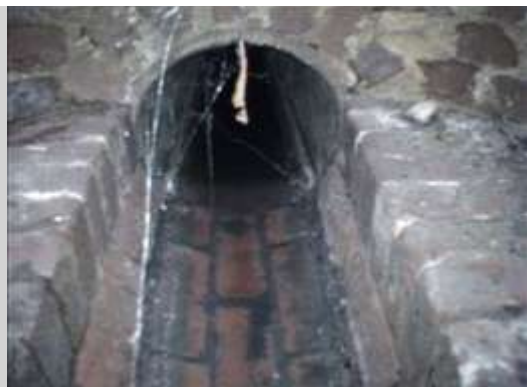
6 O'Clock Inflow

10 in. Circular Gravity Sewer
Pipe In @ 6 O'Clock

Pipe Height: **12** (in.) Rod and Bar (Angled)
Pipe Material: **Clay** ☐ Pipe Lined
Invert Depth: **7.79** (ft.) Flow Characteristics: **Slow**
Deposits: ☒ None ☐ Mud ☐ Sludge ☐ Debris ☐ Grease
Silt Depth: (in.) Deposits Extent:
Infiltration: **None** Pipe Seal Cond: **Sound**
